PREFERRED
HOME INSPECTIONS INC.

Summary

Client(s): **John Q Public**
Property address: **123 Main St.**
Everywhere USA
Inspection date: **Friday, February 26, 2016**

Property Inspection Report

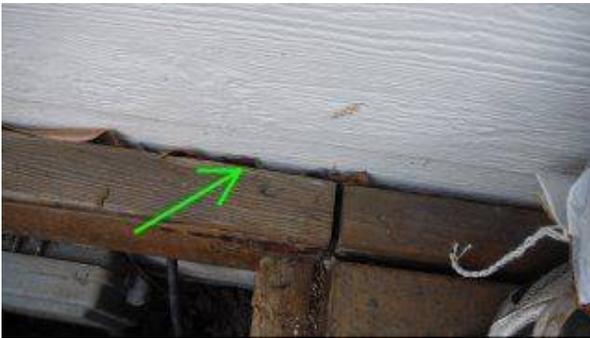
Photo 2-1

2 Safety, Repair/Replace - Flashing appeared to be missing from above deck porch ledger boards. Missing flashing at this location can cause moisture to accumulate between the ledger boards and the building. Fungal rot may occur in this area and cause the ledger board fasteners to fail. The deck may separate from the building in this event. This is a potential safety hazard. Recommend that a qualified contractor install flashing above ledger boards per standard building practices. For more information, visit:

Missing ledger flashing

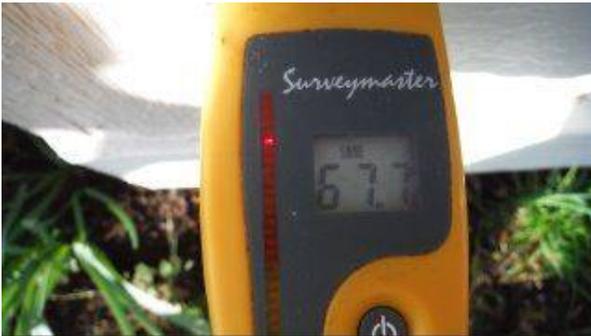
7 Repair/Maintain, Evaluate - This property was clad with composition wood-fiber siding. Various manufacturers (e.g. Louisiana Pacific, Weyerhaeuser and Masonite) have produced this type of siding, which is made from oriented strand board (OSB) or "hardboard." It is prone to deteriorate and/or fail prematurely due to moisture penetration, especially when the paint coating is substandard or has not been maintained. Failure is typically visible in the form of swelling, cracking, buckling, wafer pops, delamination and fungal growth.

Some areas of siding on this structure showed symptoms described above and need replacement and/or. The Bay window on East side at bottom 1 foot. Some manufacturers (e.g. Louisiana Pacific) recommend a repair process for this siding where affected areas are sealed with Permanizer Plus, a flexible primer made by Pittsburgh Paint, followed by two coats of 100% acrylic latex paint. This sealant must be applied to the bottom edges using a brush. The face of the siding can be sprayed. The Permanizer Plus sealer isn't required for edges that aren't swollen, cracked or deteriorated, but the acrylic latex should still be brushed on these edges.

Photo 7-1
Excessive moisture reading at bay window siding.

Recommend that a qualified contractor evaluate and replace siding as necessary, and/or seal and repaint as necessary. Repairs should be made per the siding and/or sealant manufacturer's installation instructions, and per standard building practices.

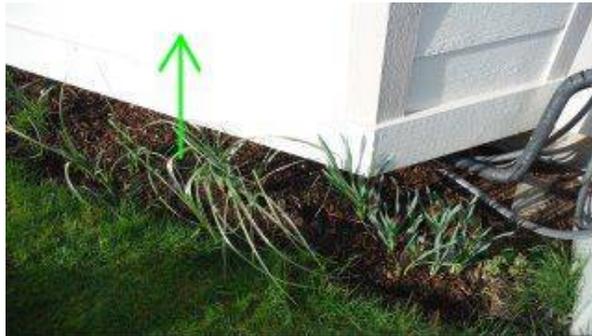
Photo 7-2
Area of damaged siding.

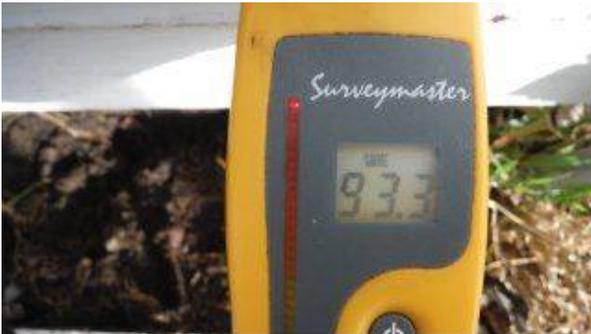
Photo 10-1

10 Repair/Replace, Evaluate, Visual Limitations - The OSB siding material on the south elevation was saturated with water and has rot present. There is also presence of insect infestation at the electrical panel on same wall at interior. Recommend removal of damaged OSB siding at said elevation and further evaluation upon removal of sheathing and structural framing members by a qualified party. Also recommend having a licensed pest inspection contractor further evaluate and treat infested area after removal of rotted materials.

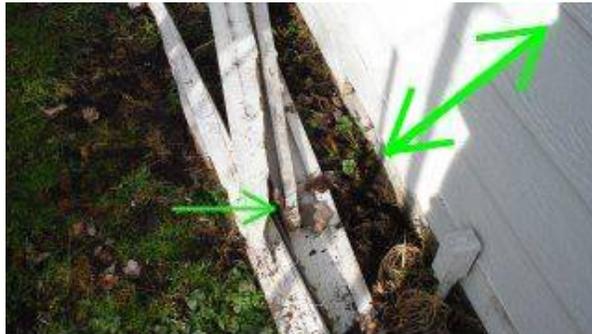
Photo 10-2
Rotten wood should be removed from area as well as the damaged siding and trim.

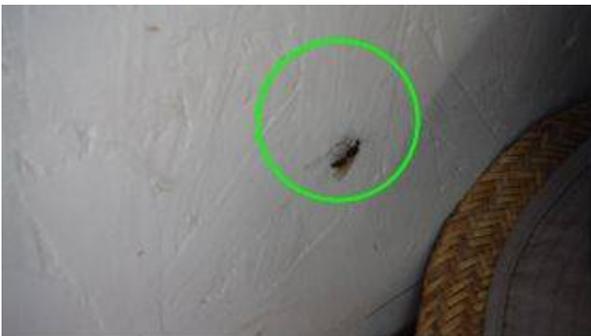
Photo 10-3
Carpenter ants found inside garage

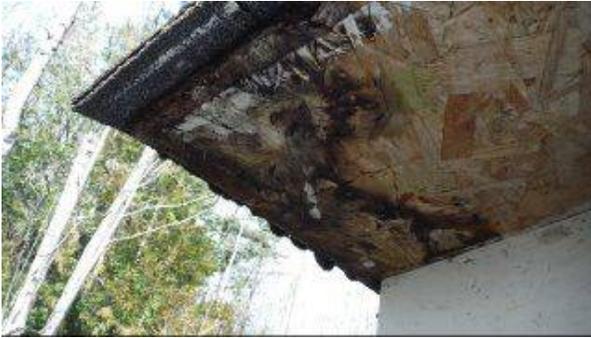
11 Repair/Replace, Visual Limitations - Damaged fascia and barge due to previous storm. Sheathing is showing signs of water damage, mildew on underside at eaves. This is conducive to rot. Recommend repair and replacement of damaged areas by qualified

Photo 11-1
Damaged area of roof sheathing and trim.

contractor.

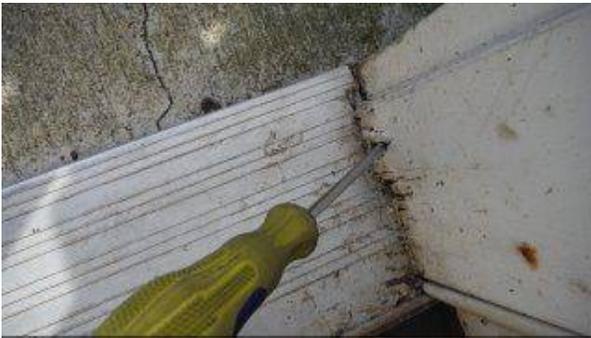
12 Repair/Replace - The entry door to detached garage has rot present at the bottom of each side jamb. This can lead to further water intrusion into structural members causing failure of door framing and lead to further rot and insect infestation. Recommend removal and replace by a qualified contractor.

Photo 12-1
Rot at door jambs

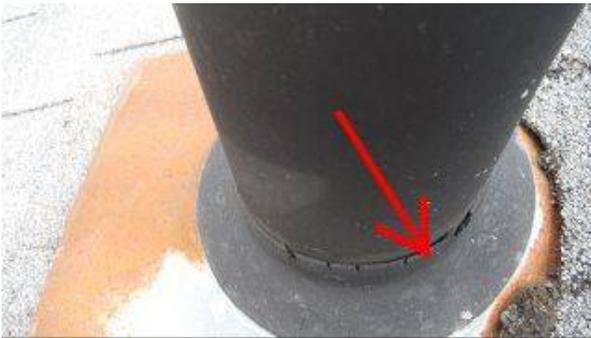
14 Repair/Replace - Rubber or neoprene pipe flashings were split or cracked. Leaks can occur as a result. This is a conducive condition for wood-destroying organisms. Recommend that a qualified contractor replace flashings where necessary.

Photo 14-1
Bad neoprene seal

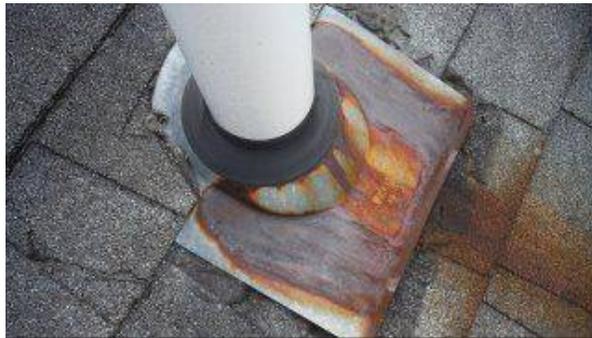
Photo 14-2
Rusting plumbing vent roof jack

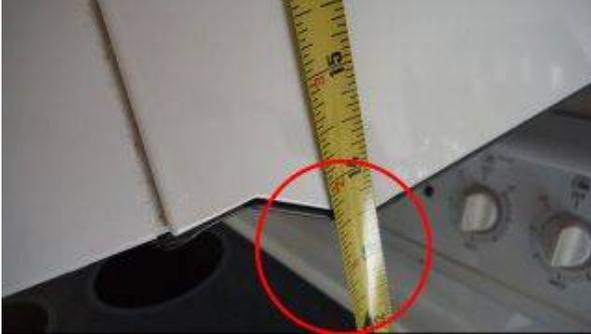
Photo 19-1

19 Repair/Replace - The clearance between the stove top and the base of the exhaust hood above was too low. While the recommended height varies per the hood manufacturer, standards usually call for a minimum of 24 inches of clearance. A low hood height can restrict visibility of the stove top. Recommend that a qualified contractor repair per standard building practices.

Microwave too close to range cooktop

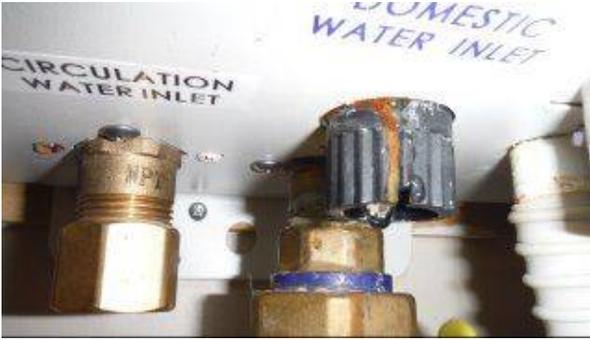
Photo 27-1

27 Repair/Replace - The water heater tank appeared to be leaking. This is an indication that the water heater has failed and is at the end of its service life. A qualified plumber should replace the water heater.

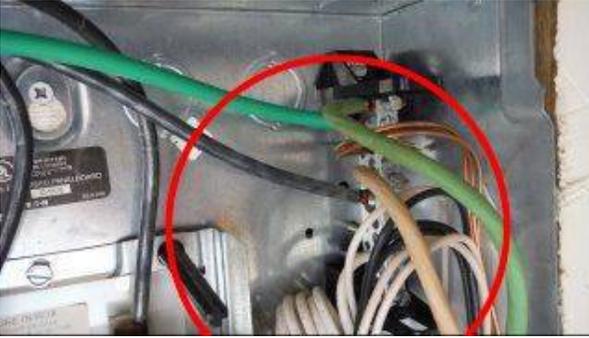
Photo 40-1

40 Safety, Repair/Replace - Neutral and equipment ground wires were bonded (connected) at sub-panel(s) # C. This should only occur in the main service panel, not sub-panels, and is a shock hazard. Neutral wires should be attached to a "floating" neutral bar not bonded to the panel, and grounding wires should be attached to a separate grounding bar bonded to the sub-panel. Recommend that a qualified electrician repair per standard building practices. For more information, visit:

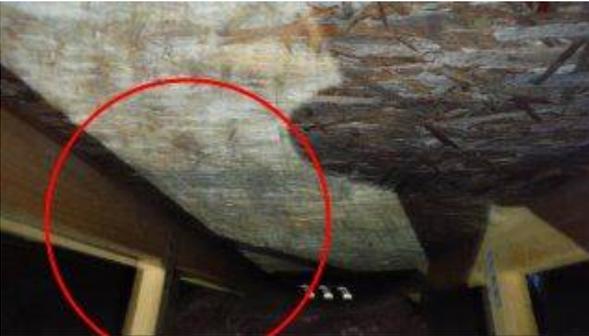
41 Safety, Repair/Maintain - The plumbing vent for the kitchen was disconnected in the attic space. This can allow moisture from the plumbing system an rain water to enter the attic area and create conducive conditions for microbial growth and condensation. It can also allow the leaking of methane gases to enter the attic space. Recommend having a qualified party re-attach the fittings with ABS glue.

Photo 41-1
Microbial staining from unconnected vent stack

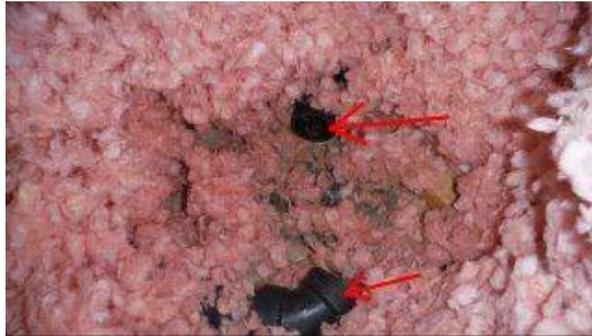
Photo 41-2
Disconnected vent stack

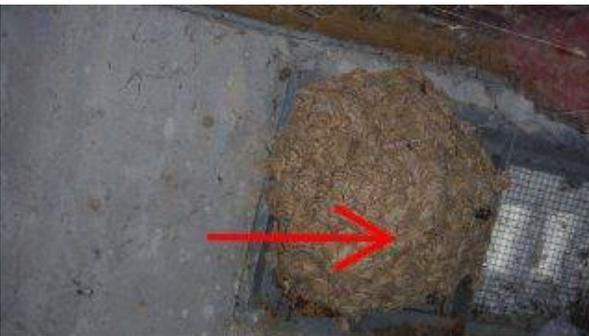
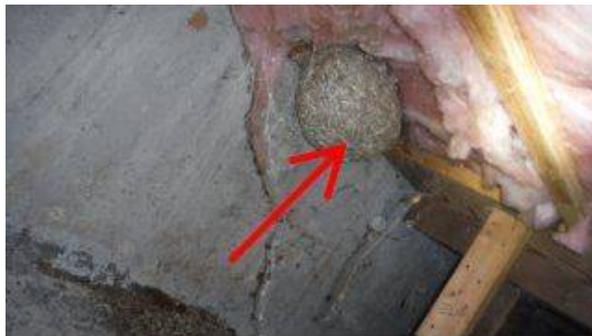
42 Safety, Repair/Maintain - There were 2 paper wasps nest in the crawl space at the south elevation foundation vents. They appears to either be empty or dormant at the time of inspection. Recommend having a qualified pest removal contractor or qualified party remove them before re-infestation.

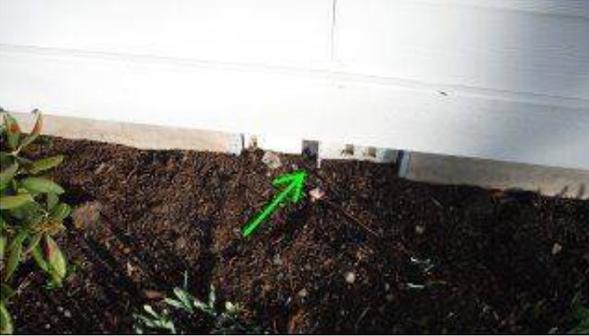
Photo 44-1

44 Repair/Replace - Several crawl space vents were below grade, no wells were installed. Vent wells should be installed when vents are at or near grade to prevent debris from blocking vents and/or water from entering vents. This is a conducive condition for wood-destroying organisms. Recommend that a qualified person install, replace or repair vent wells per standard building practices.

Install vent well here

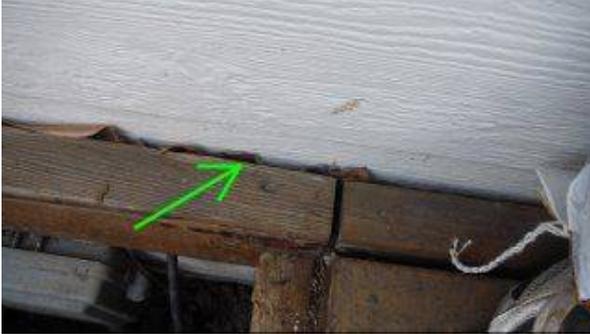
Photo 2-1

2) Safety, Repair/Replace - Flashing appeared to be missing from above deck porch ledger boards. Missing flashing at this location can cause moisture to accumulate between the ledger boards and the building. Fungal rot may occur in this area and cause the ledger board fasteners to fail. The deck may separate from the building in this event. This is a potential safety hazard. Recommend that a qualified contractor install flashing above ledger boards per standard building practices. For more information, visit:

Missing ledger flashing

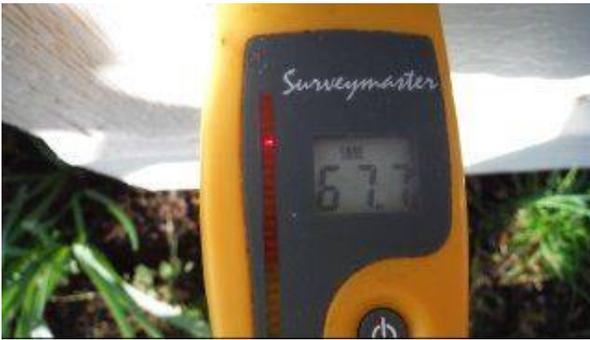
Pacific, Weyerhaeuser and Masonite) have produced this type of siding, which is made from oriented strand board (OSB) or "hardboard." It is prone to deteriorate and/or fail prematurely due to moisture penetration, especially when the paint coating is substandard or has not been maintained. Failure is typically visible in the form of swelling, cracking, buckling, wafer pops, delamination and fungal growth.

Some areas of siding on this structure showed symptoms described above and need replacement and/or. The Bay window on East side at bottom 1 foot. Some manufacturers (e.g. Louisiana Pacific) recommend a repair process for this siding where affected areas are sealed with Permanizer Plus, a flexible primer made by Pittsburgh Paint, followed by two coats of 100% acrylic latex paint. This sealant must be applied to the bottom edges using a brush. The face of the siding can be sprayed. The Permanizer Plus sealer isn't required for edges that aren't swollen, cracked or deteriorated, but the acrylic latex should still be brushed on these edges.

Photo 7-1
Excessive moisture reading at bay window siding.

Recommend that a qualified contractor evaluate and replace siding as necessary, and/or seal and repaint as necessary. Repairs should be made per the siding and/or sealant manufacturer's installation instructions, and per standard building practices.

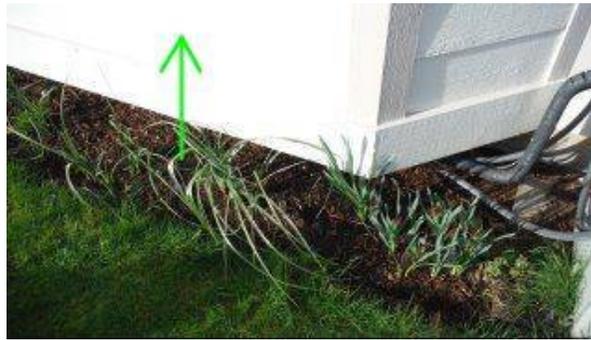
Photo 7-2
Area of damaged siding.

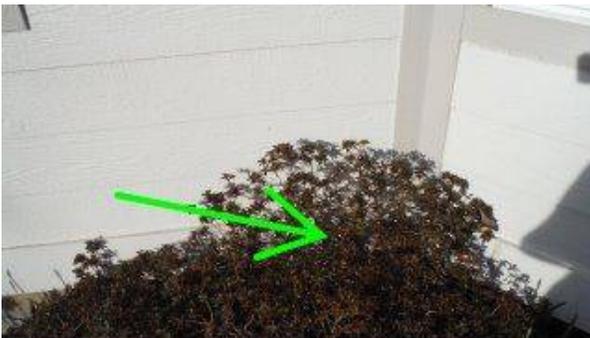
9) Maintain - Vegetation such as trees, shrubs and/or vines was in contact with or close to the building exterior. Vegetation can serve as a pathway for wood-destroying insects and can retain moisture against the exterior after it rains. This is a conducive condition for wood-destroying organisms. Recommend pruning, moving or removing vegetation as necessary to maintain at least 6 inches of space between it and the building exterior. A 1-foot clearance is better.

Photo 9-1
Vegetation too close to siding

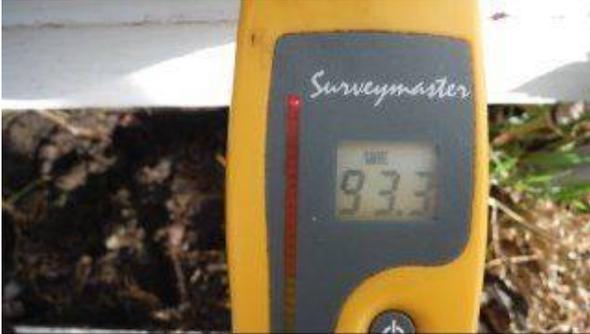
Photo 10-1

10) Repair/Replace, Evaluate, Visual Limitations - The OSB siding material on the south elevation was saturated with water and has rot present. There is also presence of insect infestation at the electrical panel on same wall at interior. Recommend removal of damaged OSB siding at said elevation and further evaluation upon removal of sheathing and structural framing members by a qualified party. Also recommend having a licensed pest inspection contractor further evaluate and treat infested area after removal of rotted materials.

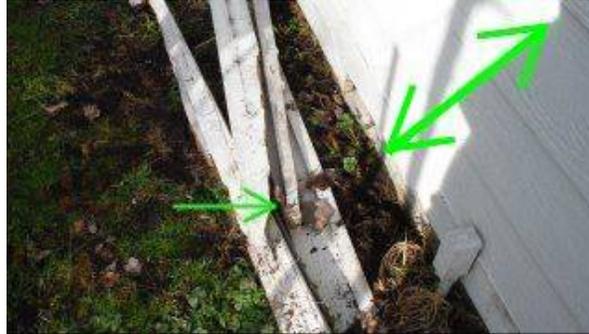
Photo 10-2

Rotten wood should be removed from area as well as the damaged siding and trim.

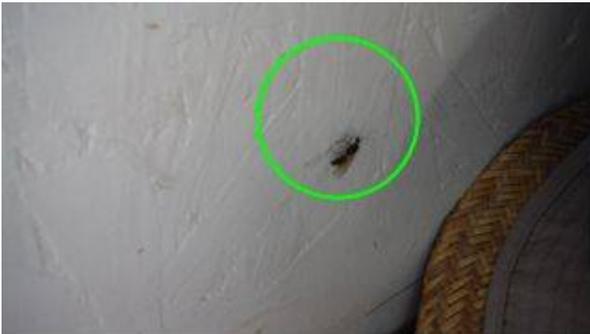
Photo 10-3

Carpenter ants found inside garage

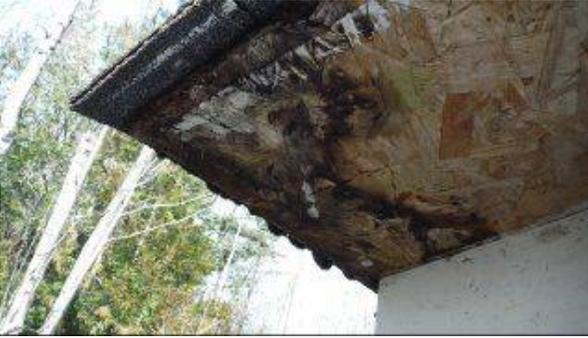
**Photo 11-1**

11) Repair/Replace, Visual Limitations - Damaged fascia and barge due to previous storm. Sheathing is showing signs of water damage, mildew on underside at eaves. This is conducive to rot. Recommend repair and replacement of damaged areas by qualified contractor.

Damaged area of roof sheathing and trim.

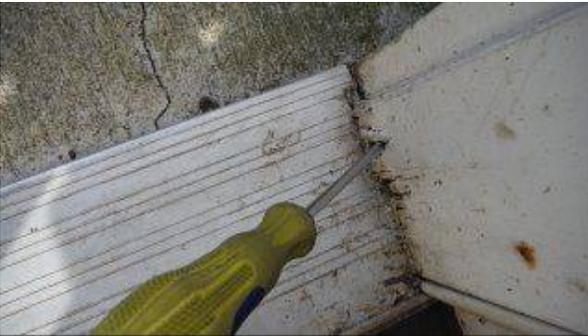
**Photo 12-1**

12) Repair/Replace - The entry door to detached garage has rot present at the bottom of each side jamb. This can lead to further water intrusion into structural members causing failure of door framing and lead to further rot and insect infestation. Recommend removal and replace by a qualified contractor.

Rot at door jambs

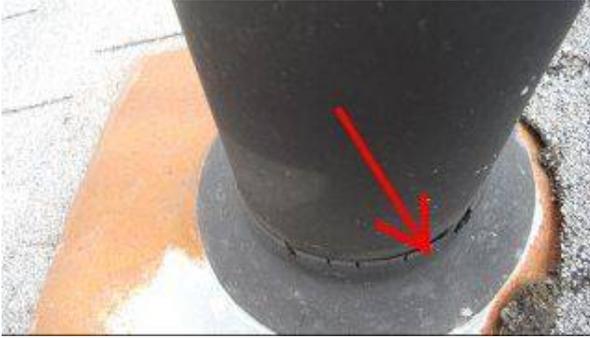
14) Repair/Replace - Rubber or neoprene pipe flashings were split or cracked. Leaks can occur as a result. This is a conducive condition for wood-destroying organisms. Recommend that a qualified contractor replace flashings where necessary.

Photo 14-1
Bad neoprene seal

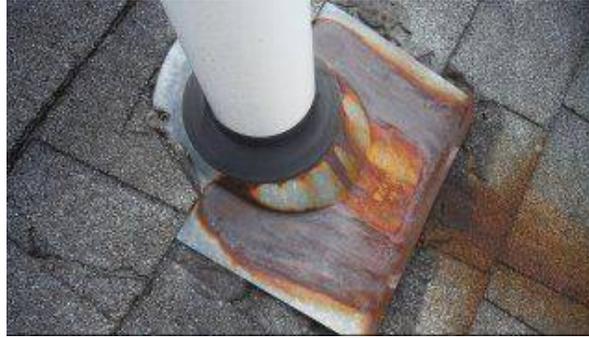
Photo 14-2
Rusting plumbing vent roof jack

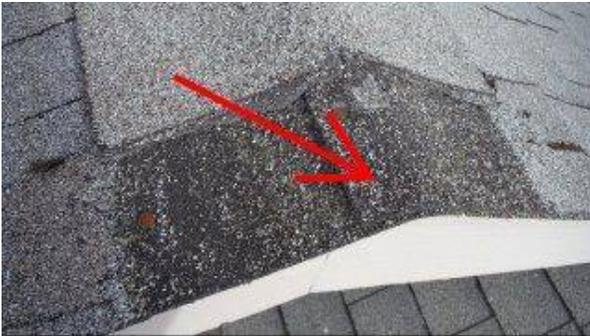
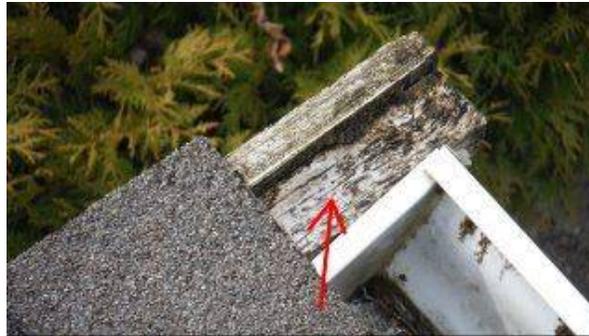
15) Repair/Maintain - There were some missing tabs and ridge cap on roof and the barge fascia tails are unprotected. This allows potential leaks and conducive conditions for wood-destroying organisms. Recommend having a qualified party repair missing shingles and ridge and add either a flashing or roofing material tab at the rafter tails.

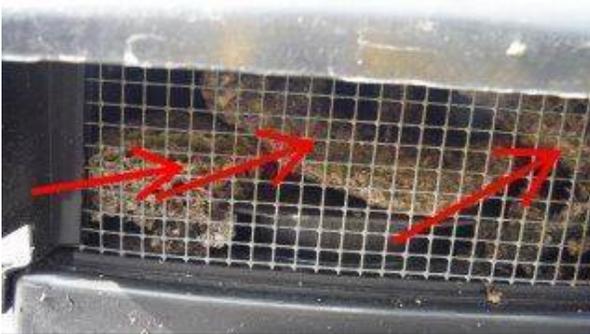
17) Maintain - There were bees nests in several vent fan terminations at the roof. This was impeding the amount of exhaust and hindering the damper action. Recommend having a qualified party remove screens and clean out the nests or remove and replace entire termination vent caps if necessary.

Photo 17-1
Abandoned bees nests

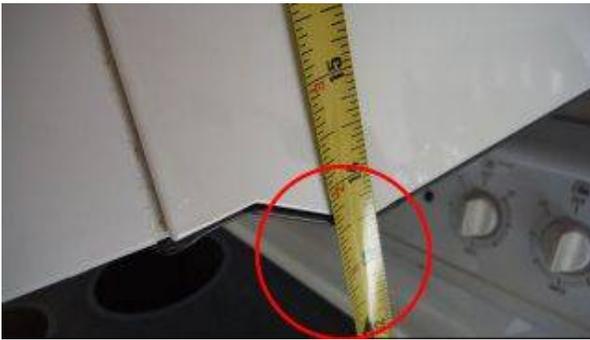
Photo 19-1

19) Repair/Replace - The clearance between the stove top and the base of the exhaust hood above was too low. While the recommended height varies per the hood manufacturer, standards usually call for a minimum of 24 inches of clearance. A low hood height can restrict visibility of the stove top. Recommend that a qualified contractor repair per standard building practices.

Microwave too close to range cooktop

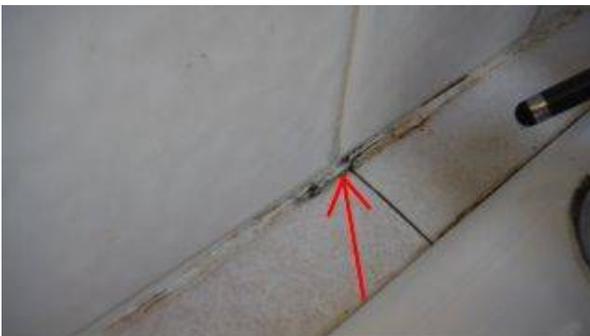
Photo 20-1

20) Repair/Maintain - Gaps, no caulk, or substandard caulking were found between countertops and backsplashes and/or around the sink. Water may penetrate these areas and cause damage. Recommend that a qualified person repair as necessary. For example, by installing caulk.

Substandard caulking

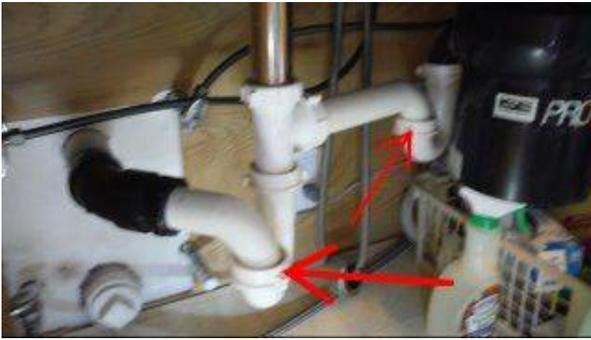
Photo 22-1

22) - Kitchen sink is plumbed with a double P-trap. This can restrict the flow of the drain. Recommend having a qualified plumber repair drain set up to current codes.

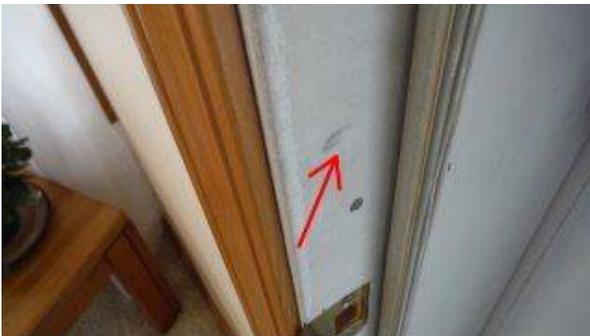
Photo 25-1

25) Repair/Maintain - Deadbolt on the southwest door was inoperable. Recommend that a qualified person repair as necessary.

Southwest entry door needs jamb strike installed

Southwest door deadbolt strike missing

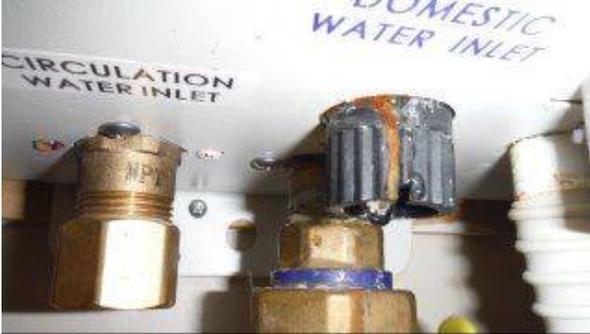
Photo 27-1

27) Repair/Replace - The water heater tank appeared to be leaking. This is an indication that the water heater has failed and is at the end of its service life. A qualified plumber should replace the water heater.

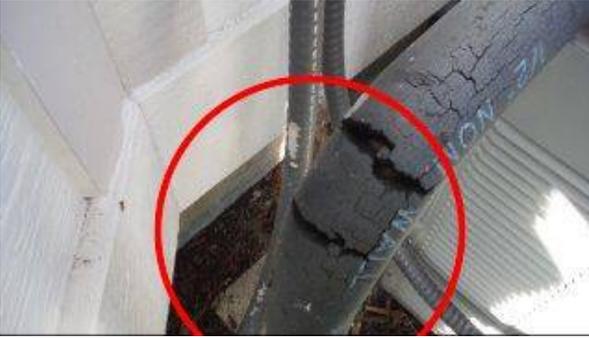
29) Minor Defect - Insulation on A/C line set is deteriorating. This could affect efficiency of cooling. Recommend having a qualified HVAC contractor repair as necessary.

Photo 29-1
Insulation deteriorating

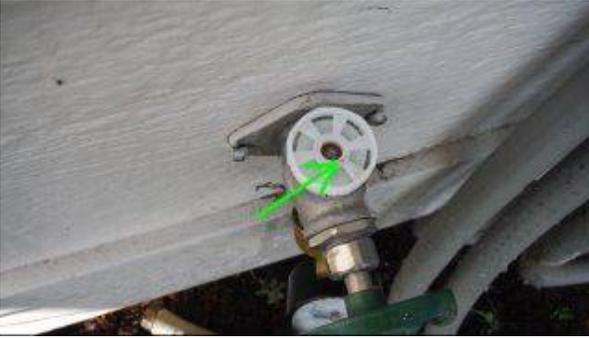
**Photo 34-1**

34) Repair/Maintain - The two hose bibs at the exterior had minor issues, the northwest hose bib bonet is leaking, possibly needs tightening, the southeast hose bib is missing the vacuum breaker cap. Recommend having a qualified plumber repair

Southeast hose bib missing vacuum breaker cover

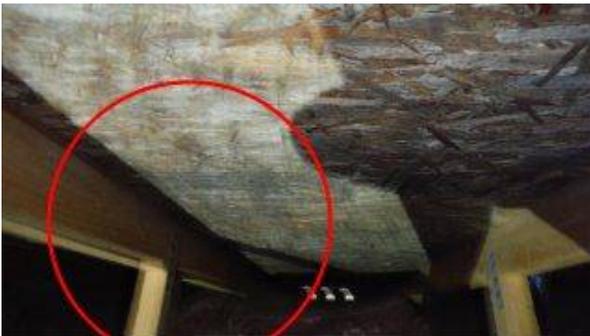
Photo 41-1

41) Safety, Repair/Maintain - The plumbing vent for the kitchen was disconnected in the attic space. This can allow moisture from the plumbing system an rain water to enter the attic area and create conducive conditions for microbial growth and condensation. It can also allow the leaking of methane gases to enter the attic space. Recommend having a qualified party re-attach the fittings with ABS glue.

Microbial staining from unconnected vent stack

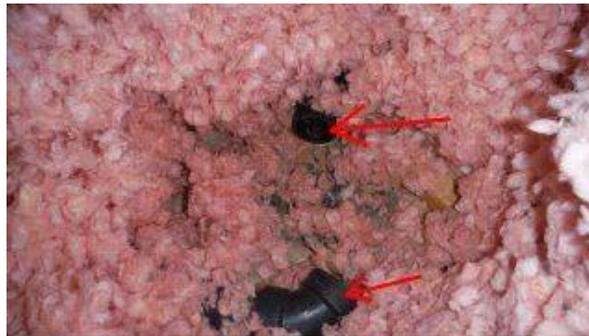
Photo 41-2

Disconnected vent stack

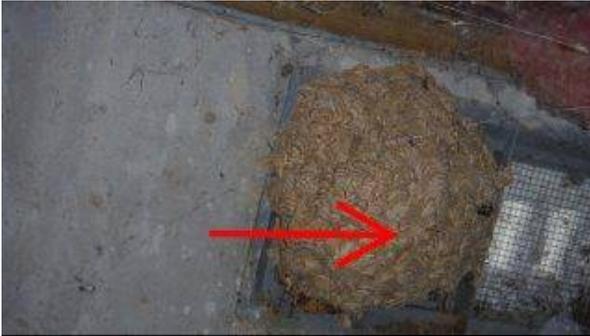
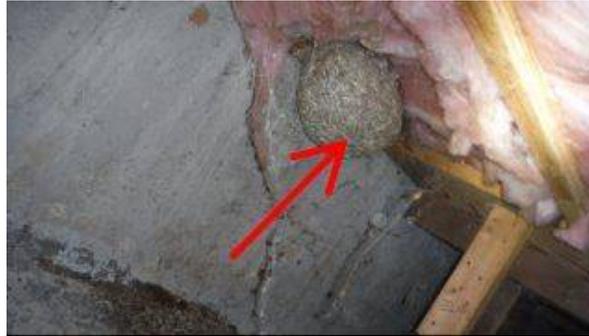
42) Safety, Repair/Maintain - There were 2 paper wasps nest in the crawl space at the south elevation foundation vents. They appears to either be empty or dormant at the time of inspection. Recommend having a qualified pest removal contractor or qualified party remove them before re-infestation.

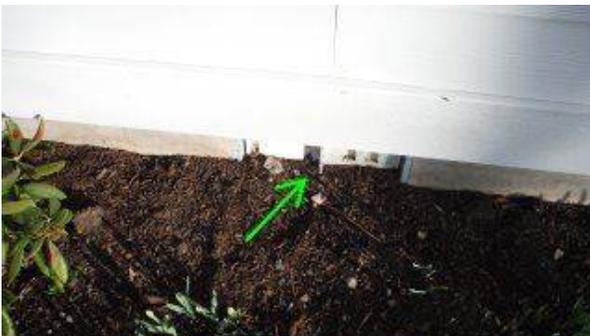
Photo 44-1

44) Repair/Replace - Several crawl space vents were below grade, no wells were installed. Vent wells should be installed when vents are at or near grade to prevent debris from blocking vents and/or water from entering vents. This is a conducive condition for wood-destroying organisms. Recommend that a qualified person install, replace or repair vent wells per standard building practices.

Install vent well here

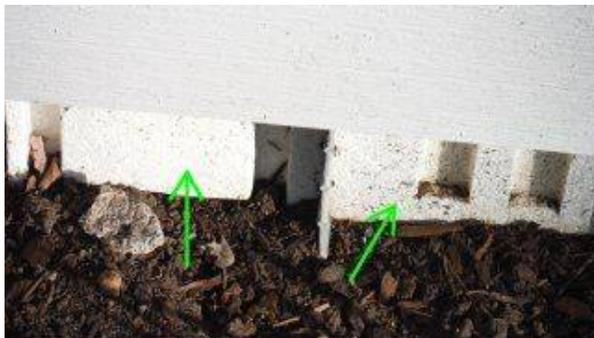
Photo 45-1

should be left open at all times except during severe freezing weather. Recommend removing materials or items blocking vents as necessary.

Intentionally blocked vents not recommended, restricts necessary crawl space ventilation.
