PREFERRED
HOME INSPECTIONS INC.

Summary

Client(s): **John Q Public**
Property address: **123 Main St.**
Everywhere USA
Inspection date: **Friday, February 26, 2016**

Property Inspection Report

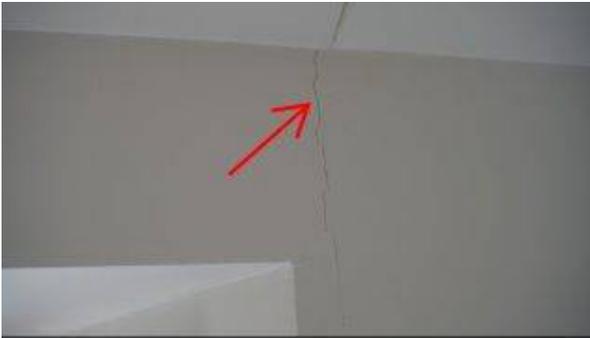
Photo 24-1

24) Repair/Maintain, Minor Defect - Minor cracks, nail pops and/or blemishes were found in walls and ceilings in several areas. Cracks and nail pops are common, are often caused by lumber shrinkage or minor settlement, and can be more or less noticeable depending on changes in humidity. They did not appear to be a structural concern, but the client may wish to repair these for aesthetic reasons. For recurring cracks, consider using an elastic crack covering product:

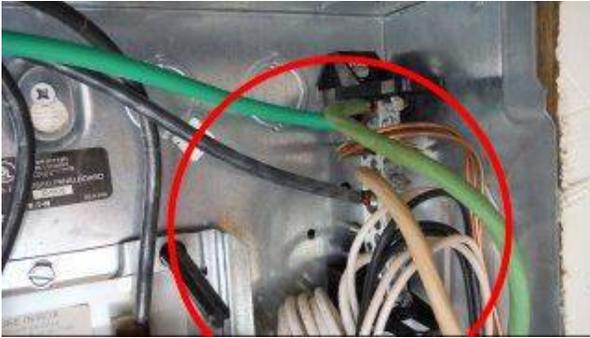
Photo 40-1

40) Safety, Repair/Replace - Neutral and equipment ground wires were bonded (connected) at sub-panel(s) # C. This should only occur in the main service panel, not sub-panels, and is a shock hazard. Neutral wires should be attached to a "floating" neutral bar not bonded to the panel, and grounding wires should be attached to a separate grounding bar bonded to the sub-panel. Recommend that a qualified electrician repair per standard building practices. For more information, visit:
